RM No. E6L10

RESEARCH MEMORANDUM

THE EFFECT OF PREIGNITION ON CYLINDER TEMPERATURES

PRESSESURES, POWER OUTPUT, AND PISTON FAILURES

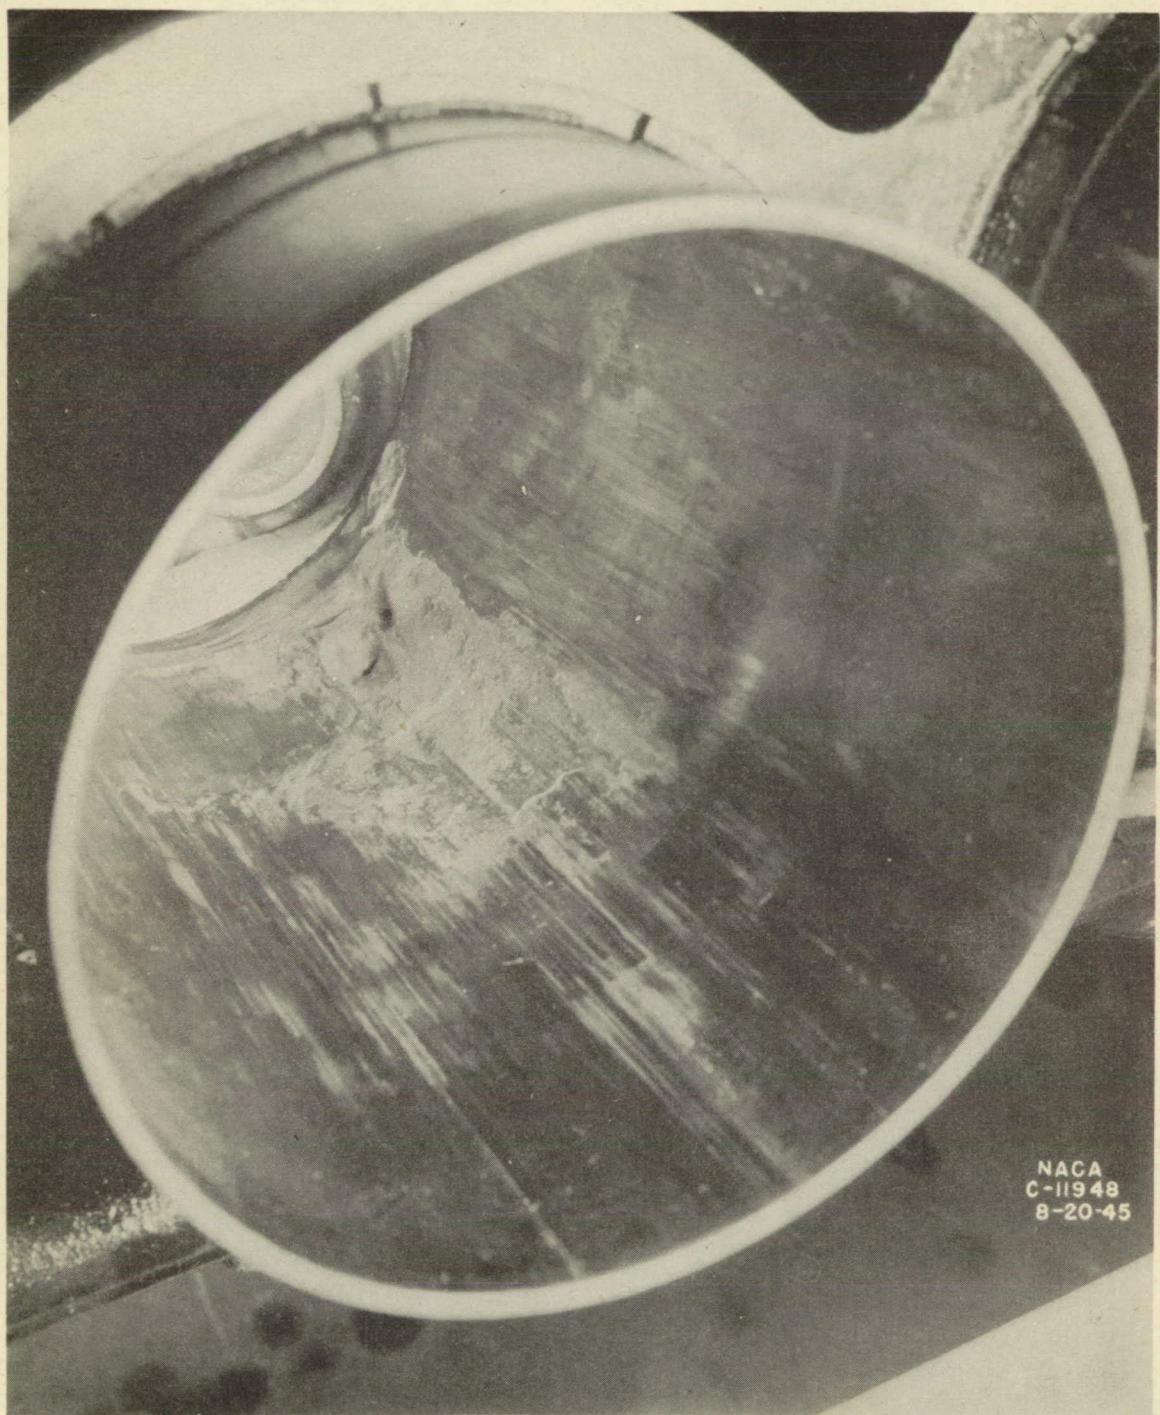
Fig. 15

Photographs of damage to other cylinder parts that accompanied the piston failures in two of the runs are also presented. Figure 14 shows an exhaust valve that burned at the time of the piston failure shown in figure 12(b). Inasmuch as two other runs were made at more severe operating conditions without valve failure, it is felt that this failure was brought about by particles of aluminum or other substance lodging between the valve and its seat. Figure 15 shows the damage to the cylinder barrel that accompanied the piston failure shown in figure 12(c). The torching action of the hot gases burned through the barrel into the coolant passage.

Figure 15. - Damage to cylinder barrel caused by piston failure of figure 12(c).
